Evaluating the Infiltration Performance of Eight Dutch Permeable Pavements Using a New Full-Scale Infiltration Testing Method

Keywords: permeable pavements; infiltration rate; clogging; SUDS; full-scale test method

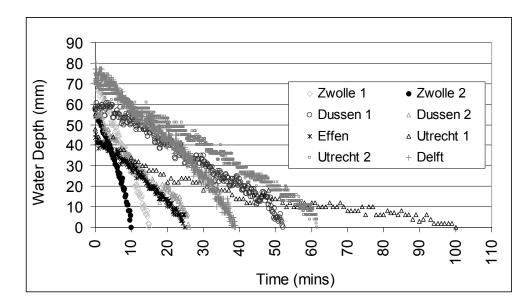
Figure 7. Infiltration curve results for the eight permeable pavements tested in the study.

The surface infiltration rates recorded for each of eight test pavements using the new experimental test procedure are shown in Figure 7.

All eight test pavements (Table 1) were sealed, inundated and monitored as described above. The pressure transducer readings were then plotted against time to generate precise infiltration curves for each of the test sites (Figure 7). Simple linear regression analysis was used to generate lines of best fit for the transducer readings from each site. The equations of the linear regression lines were then used to calculate the average infiltration rate in mm/h for each test site (Table 1).

Although the eight permeable pavements tested in this study were of a similar construction type and of similar age, Table 2 shows a large variation in the calculated infiltration rates between the eight study pavements. This variation in results is similar to the findings of a number of previous studies that have attempted to quantify the infiltration rates of permeable pavements [4,13,16,21–23]. The infiltration rates of the eight test pavements differed from between 29 and 342 mm/h.
